REPORT FOR THE
SOUTH DAKOTA DEPARTMENT OF TRANSPORTATION

Major Bridge Investment Study

FHU Reference No. 14-381
August 2016

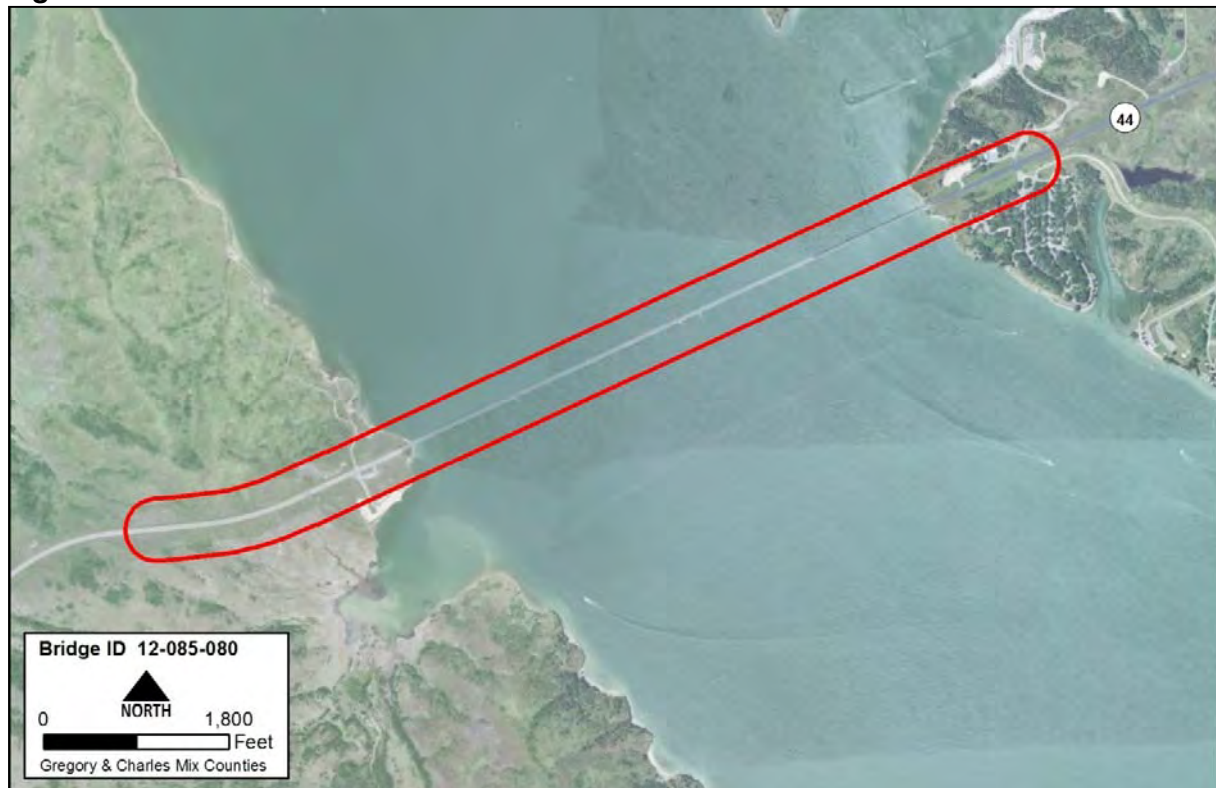
Figure 3.1 SD 44 – Structure # 12-085-080

Structure No. 12-085-080 (Platte/Winner) is located on South Dakota Highway 44 (SD 44) over the Missouri River in Charles Mix County. The study area, shown in **Figure 3.1**, is approximately 1.85 miles long and 600 feet wide, centered on the structure and its approaches. However, the search area for Nationwide River Inventory rivers and South Dakota Department of Environment and Natural Resources (SDDENR) Active Program Sites extends 0.5 miles upstream and downstream from the structure.

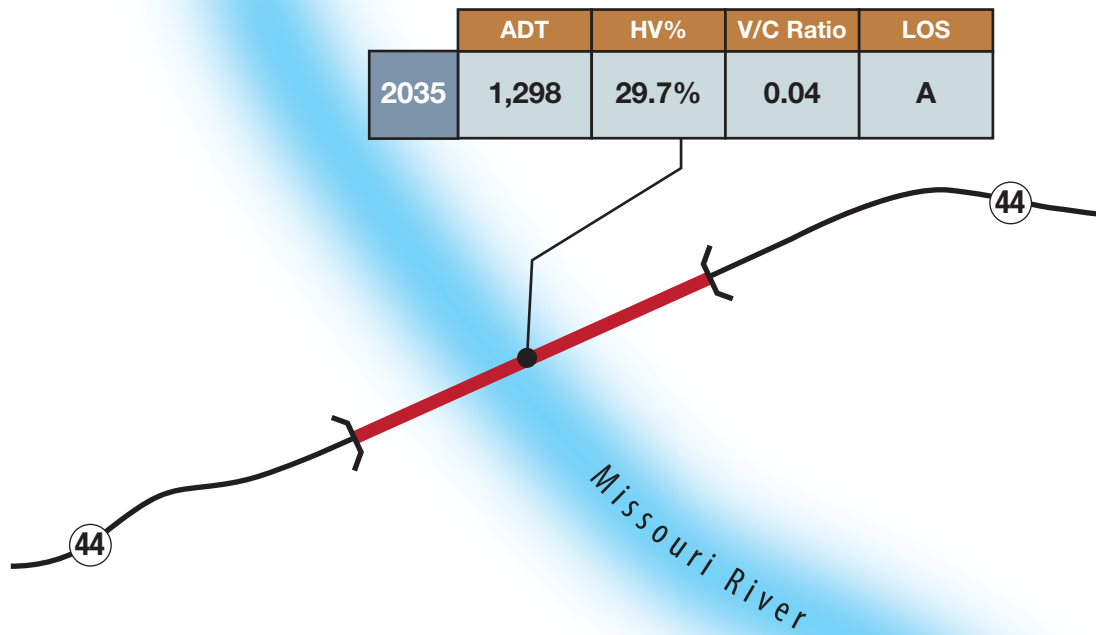
LEGEND	
Number of Lanes	2 Lanes
Functional Class	Rural Minor Arterial
Posted Speed	65 mph
Bridge Roadway Width	36 Feet

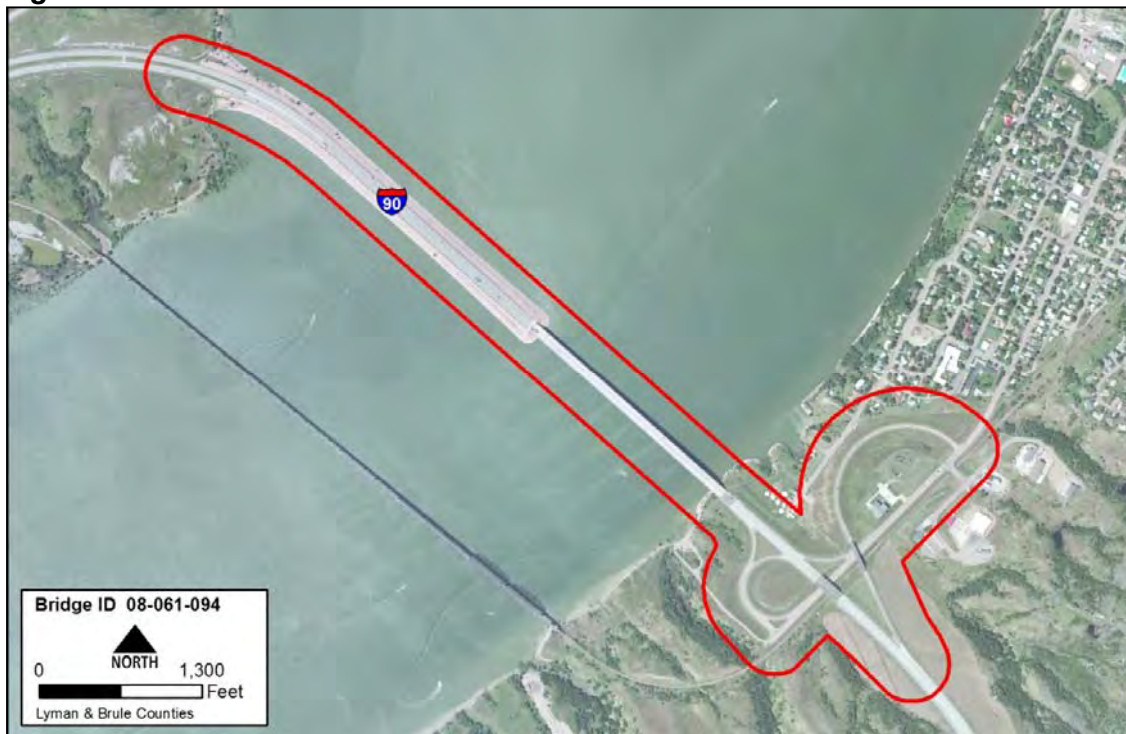
Figure 6.1 I-90 E & W – Structure # 08-061-094

This structure was constructed in 1974. The team conducted a full analysis and review of the structure and the approaches, including baseline conditions, future needs, and safety analyses. **Chapter 19** presents alternative maintenance and replacement scenarios developed for this structure.

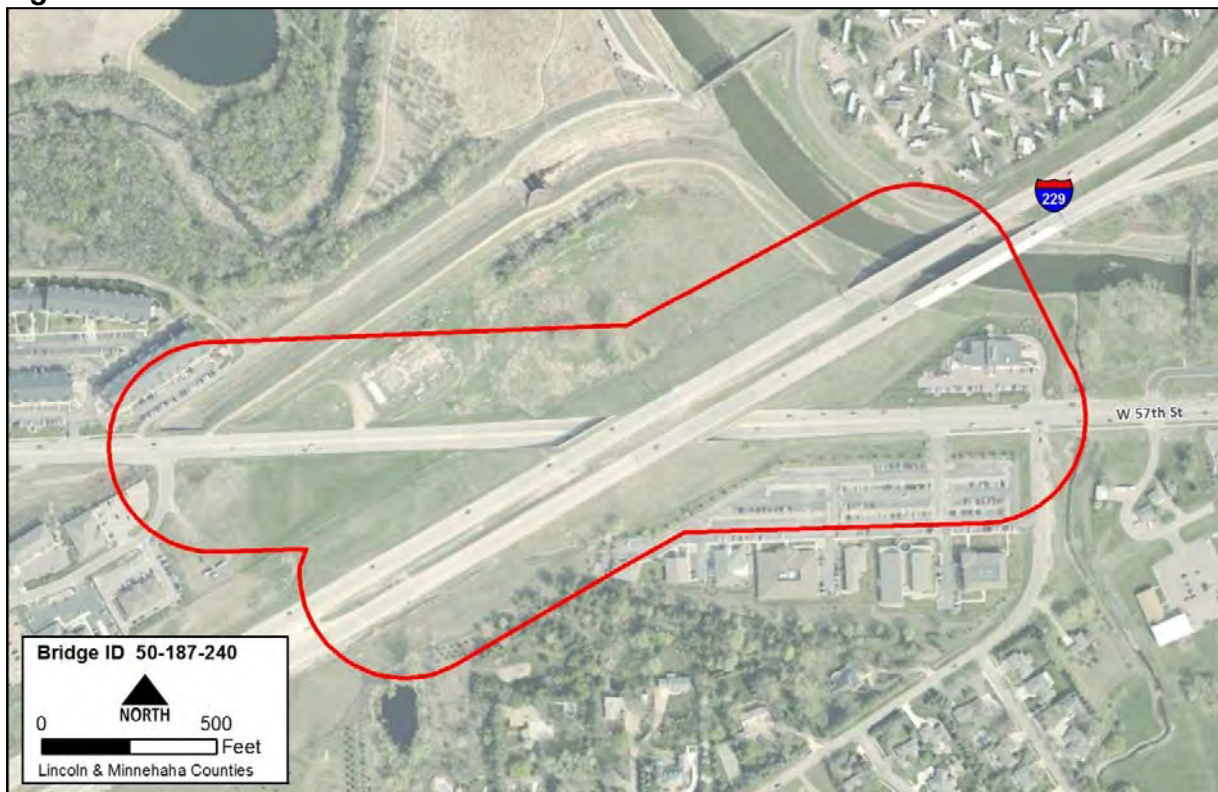
Figure 7.1 I-229 N & S – Structure # 05-187-240

This structure was constructed in 1995. Because this structure is currently under study as a part of the *I-229 Major Investment Corridor Study*, the team provided a cursory level review, including baseline conditions, future needs, and safety analyses. The team did not develop alternative improvement scenarios for this structure.

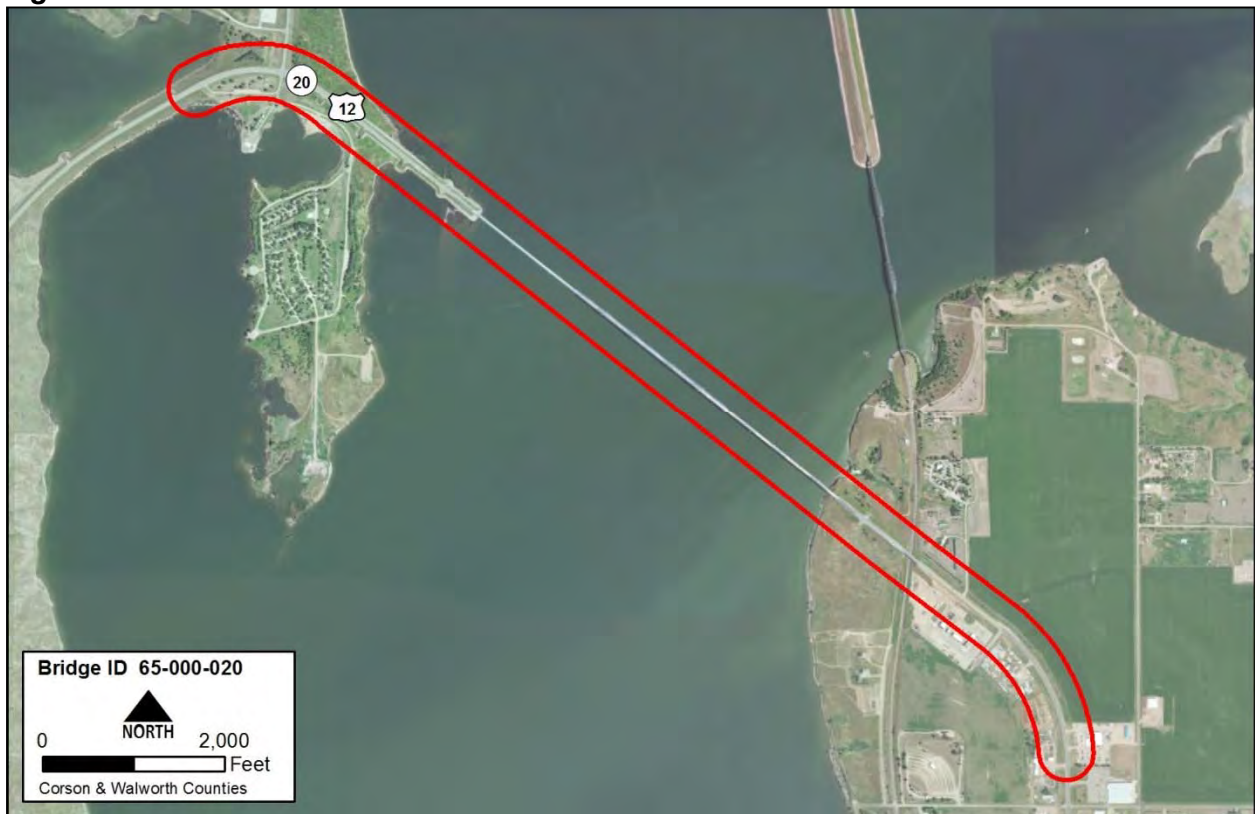
Figure 10.1 US 12 – Structure # 65-000-020

Structure No. 65-000-020 (US 12 – Mobridge) crosses the Missouri River, immediately northwest of Mobridge. The study area is approximately 2.5 miles long and 600 feet wide, centered on the structure and its approaches. However, the search area for Nationwide River Inventory rivers and South Dakota Department of Environment and Natural Resources (SDDENR) Active Program Sites extends 0.5 miles upstream and downstream from the structure.

This structure, constructed in 1959, underwent a major rehabilitation in 1980. The team conducted a full analysis and review of the structure and the approaches, including baseline conditions, future needs, and safety analyses. **Chapter 19** presents alternative maintenance and replacement scenarios developed for this structure.

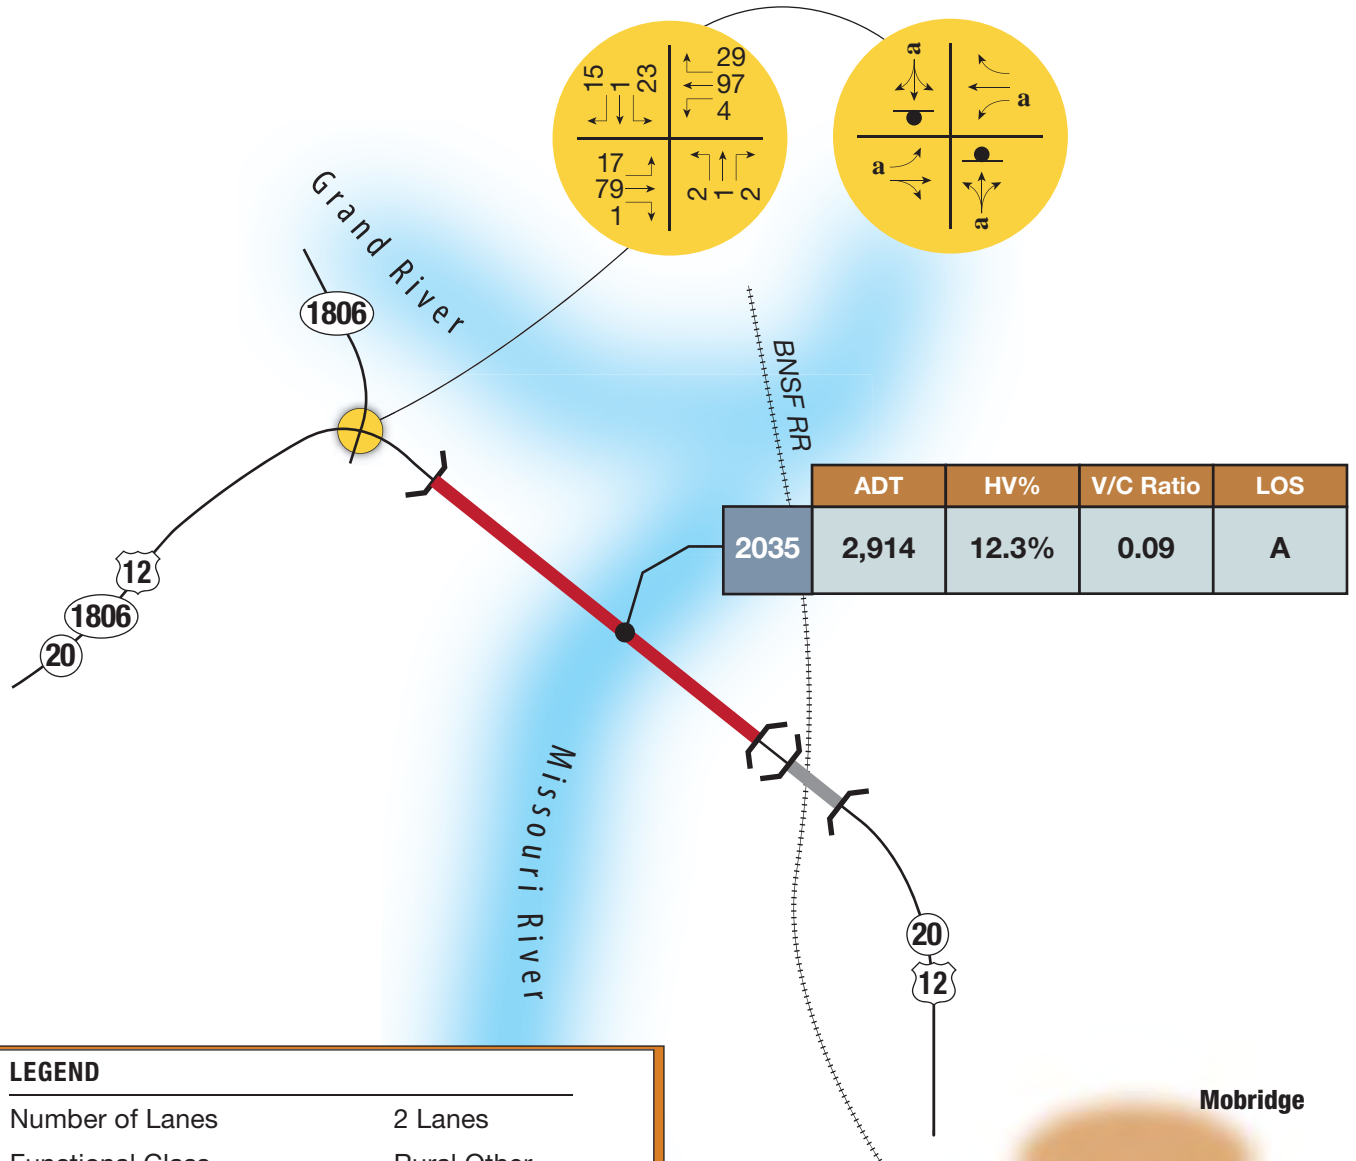
LEGEND

Number of Lanes	2 Lanes
Functional Class	Rural Other Principal Arterial
Posted Speed	55 mph
Bridge Roadway Width	26 Feet

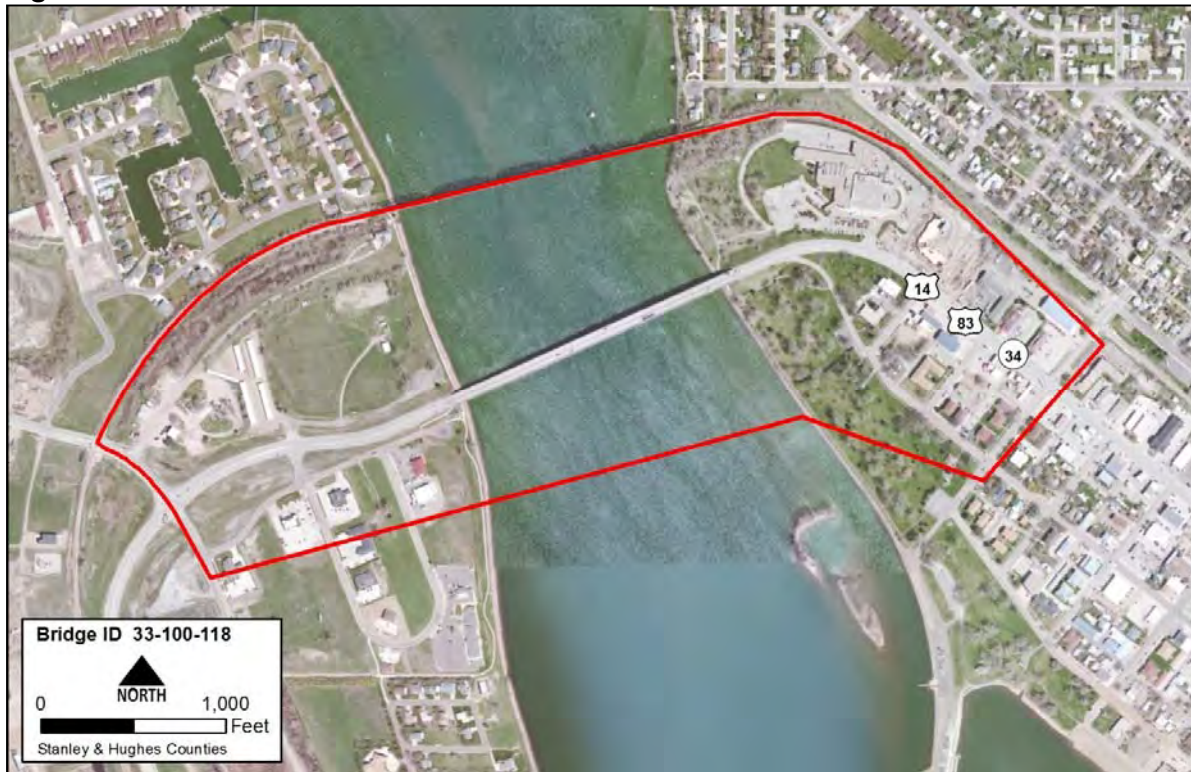
Figure 11.1 US 14/US 83/SD 34 – Structure # 33-100-118

This structure was constructed in 1962. Because a study is currently underway for this structure, only a cursory level review was needed. A cursory level review includes baseline conditions, future needs, and safety analyses. The team did not develop alternative improvement scenarios for this structure.

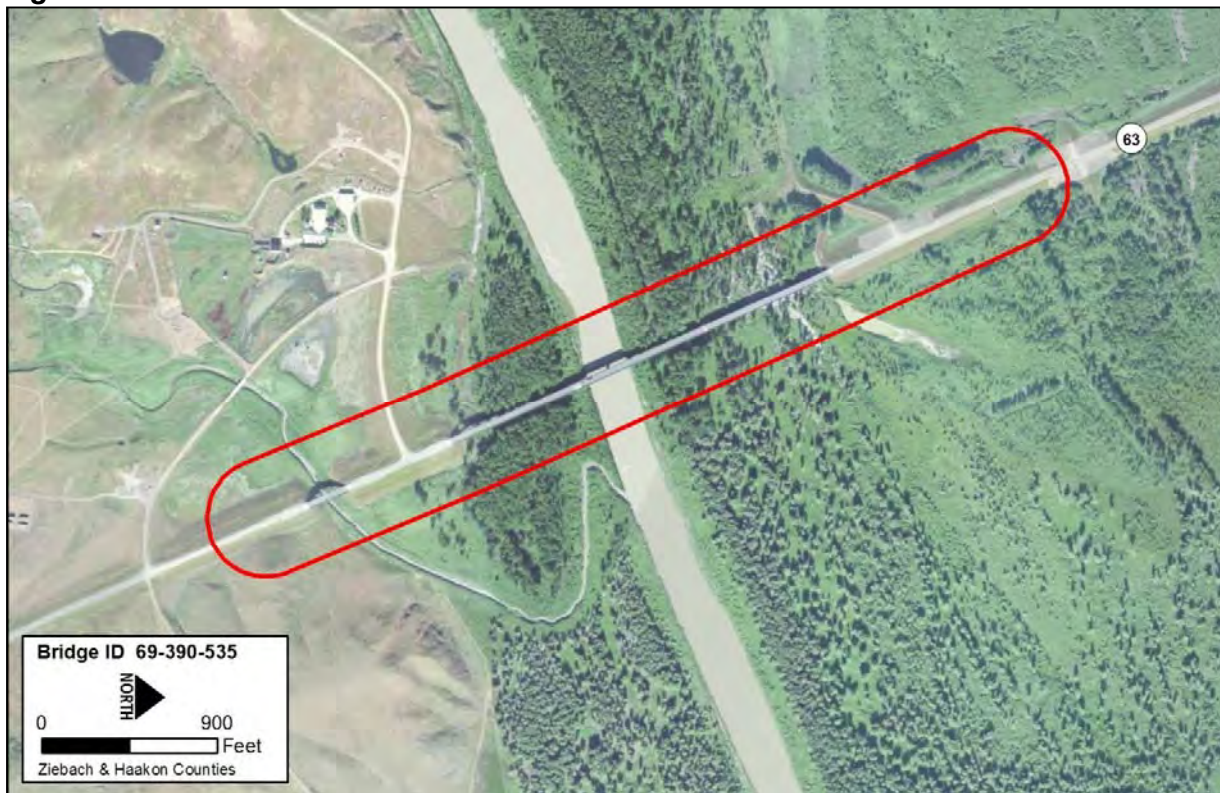
Figure 13.1 SD 63 – Structure # 69-390-535

This structure was constructed in 1981. The team conducted a full analysis and review of the structure and the approaches, including baseline conditions, future needs, and safety analyses. **Chapter 19** presents alternative maintenance and replacement scenarios developed for this structure.

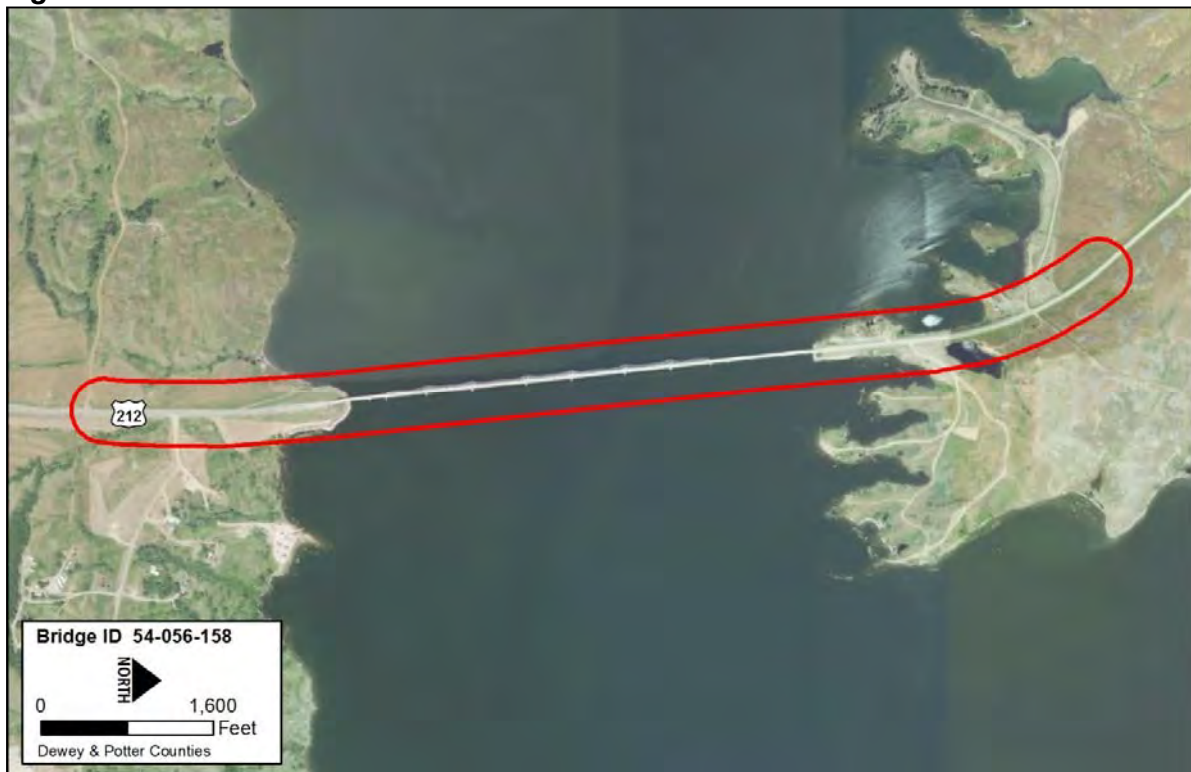
Figure 14.1 US 212 – Structure # 54-056-158

This structure, constructed in 1958, underwent a major rehabilitation in 1980. The team conducted a full analysis and review of the structure and the approaches, including baseline conditions, future needs, and safety analyses. The team developed and evaluated alternative improvement scenarios for this structure.

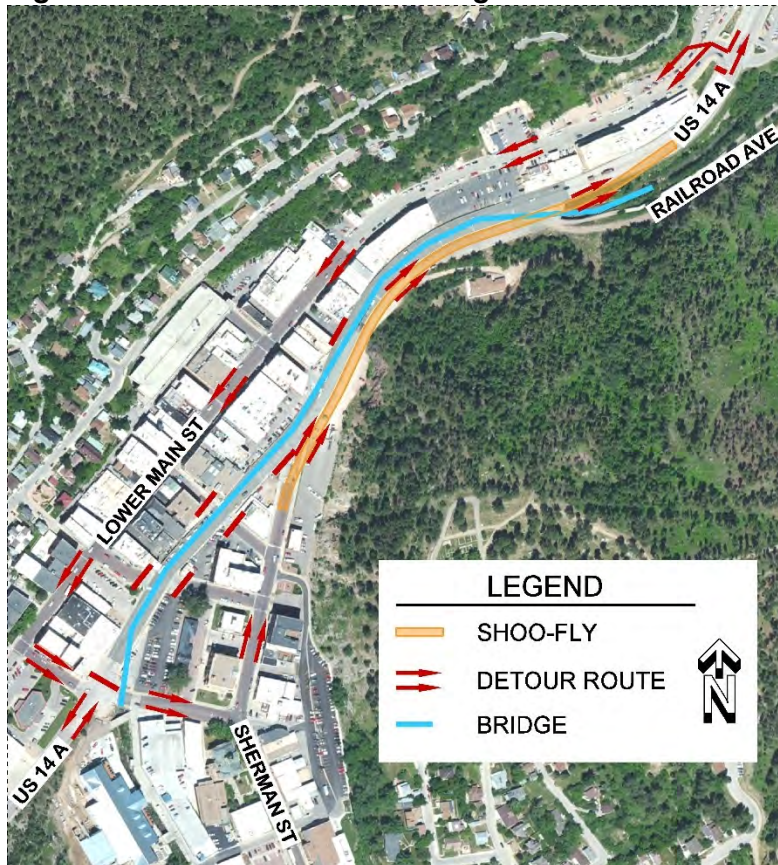
Figure 16.5 Traffic Detour during Construction

It is recommended that a more detailed analysis of traffic control be developed with the reconstruction plans for the Deadwood Box. The exact location of the existing box would need to be determined to ensure that there is adequate room near the west edge of the existing box to construct the new box for the segment north of Sherman Street.

Because much of the Deadwood Box is located directly under US 14A, challenges will be associated with traffic maintenance during reconstruction. One option for maintaining two lanes of traffic in each direction would be to develop a one-way pair system using Main Street to the west for two-lanes of southbound travel, and the combination of Sherman Street and a shoofly on the east side of existing US 14A for two-lanes of northbound travel (see **Figure 16.5**).

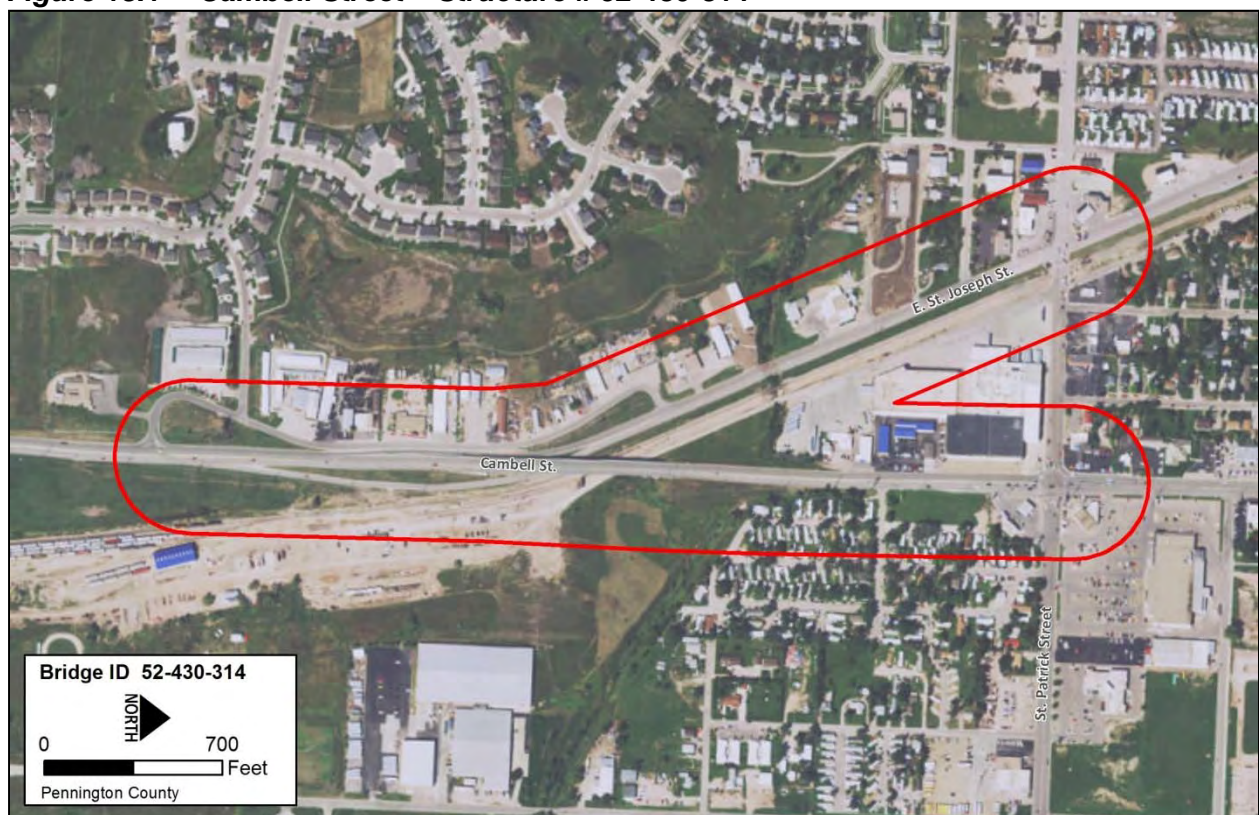
Figure 18.1 Cambell Street – Structure # 52-430-314

This structure was constructed in 1964. The team conducted a full analysis and review of the structure and the approaches, including baseline conditions, future needs, and safety analyses. **Chapter 19** presents alternative maintenance and replacement scenarios developed for this structure.

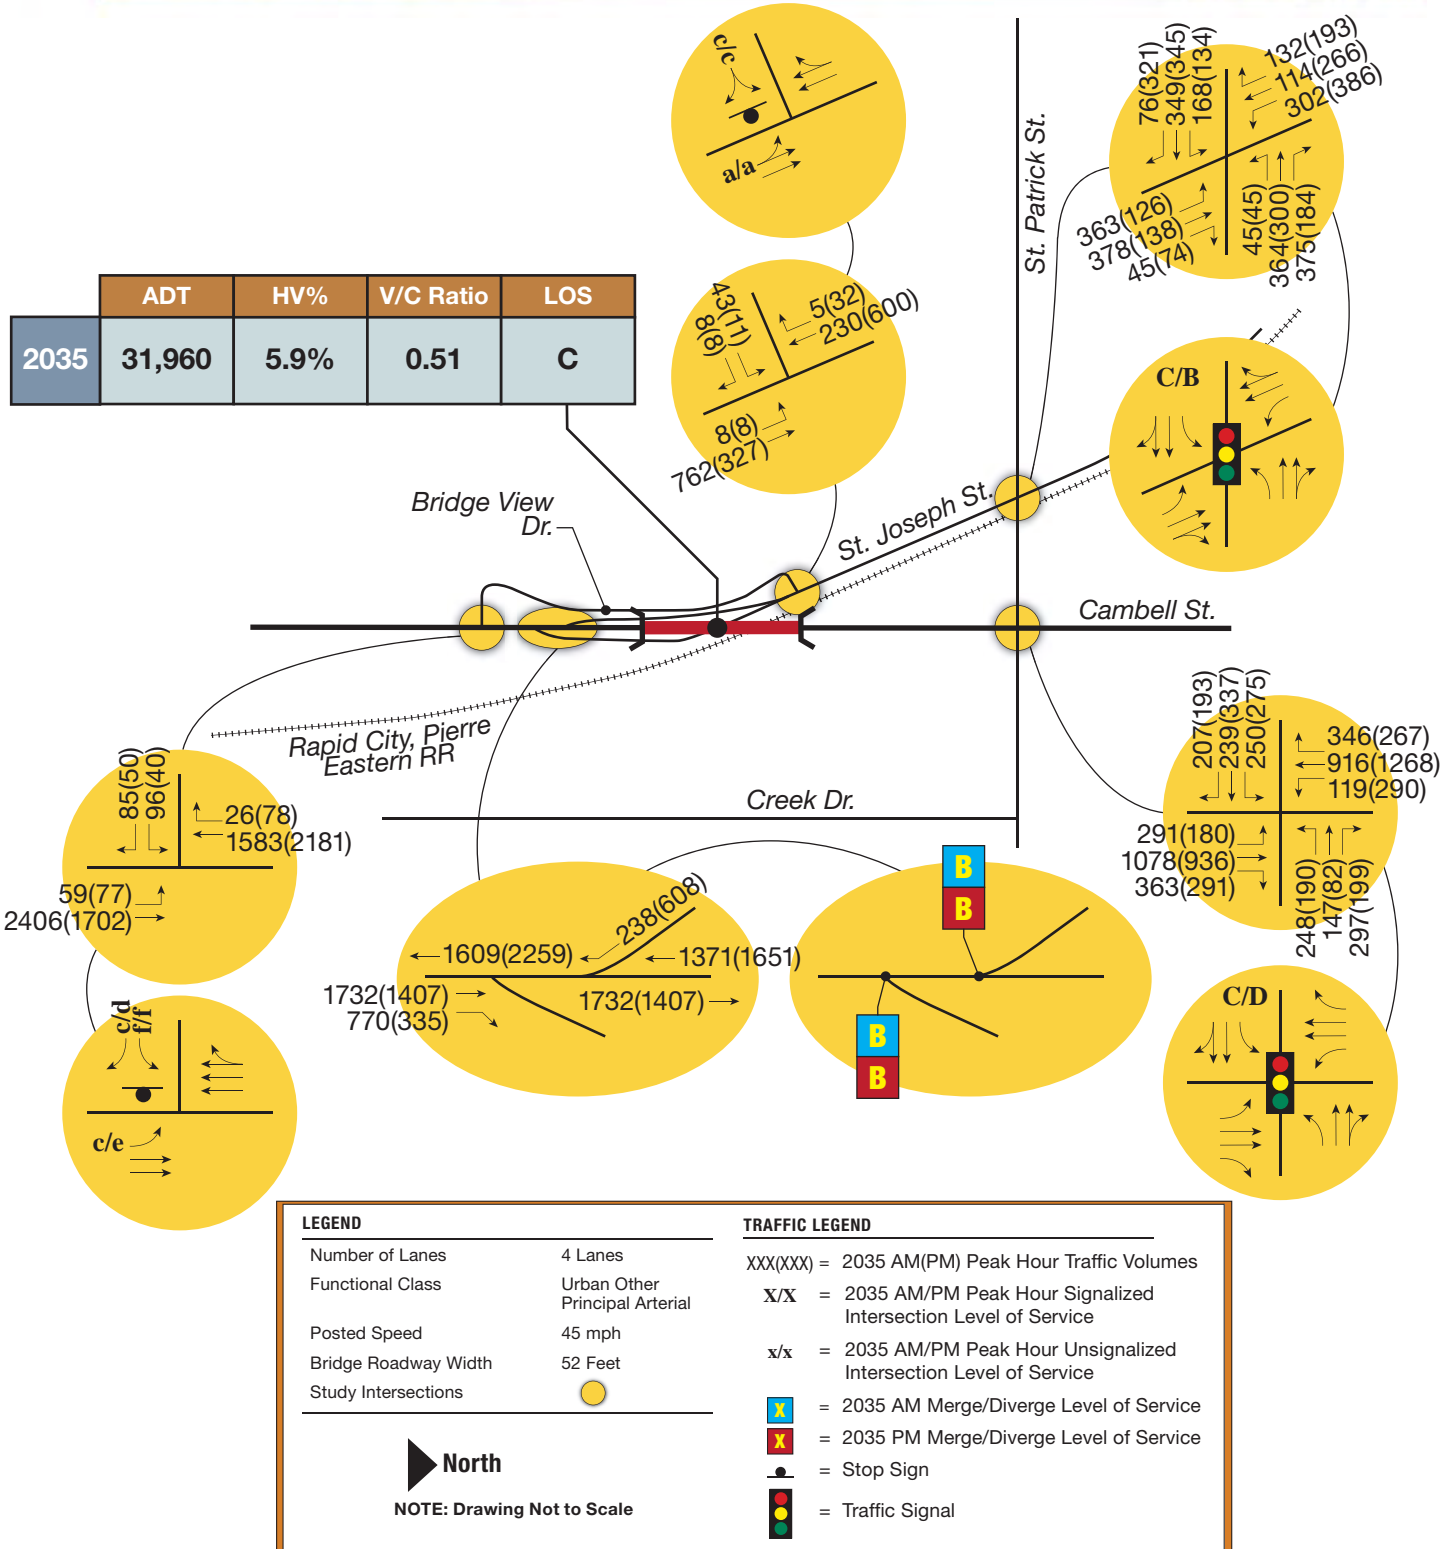
Figure 18.4

2035 Future Conditions
Cambell Street
52-430-314

peak hours, with the exception of the eastbound left-turn lane, which operates at LOS F in both peak periods, and the northbound left-turn lane, which is anticipated to operate at LOS E in the PM peak hour. It should be noted that it is not uncommon for unsignalized side street movements to operate at LOS F in peak hours in urban areas. A MUTCD traffic signal warrant analysis was completed for 2035 traffic volumes and signal warrants were not satisfied. A right-turn reduction of 100 percent was applied. If a traffic signal were installed, traffic operations of LOS A or LOS B would be anticipated. The signalized intersections of St. Patrick Street with St. Joseph Street and Cambell Street are anticipated to operate at LOS D or better in the AM and PM peak hours. **Figure 18.4** summarizes the future roadway and traffic conditions.

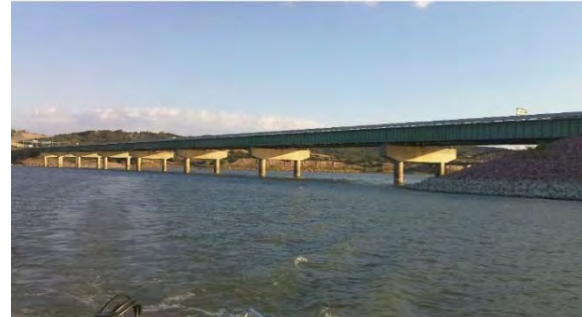
Figure 19.5 Upstream Elevation

- *Foundation*: Underwater
- Predictability
 - *Superstructure*: Two-girder system with floor beams and stringers
 - *Substructure*: Two-column bents with individual footings

- *Foundation*: Some individual spread footings with ice and wind loads applied
- Critical Factor
 - *Superstructure*: Two-girder system, detectable deficiencies, limited redundancy

- *Substructure*: Two-column bents with low redundancy
 - *Foundation*: Scour at spread footings could cause critical failure
- Historical Evidence
 - *Superstructure*: Deck and soffit cracking (minor deficiency progressing), minor fatigue cracking appears stable

- *Substructure*: Minor surface cracks appear stable
 - *Foundation*: Scour appears to be progressing at Pier 8 (pier is founded on chalk, SDDOT geotech confirms this layer is stable in scour conditions), spreading of embankment is occurring at east abutment

Table 19.10 summarizes the uncertainty index for this bridge. This evaluation indicates that the superstructure and substructure have medium uncertainty and will likely require increased maintenance to preserve their lifespans. Due to the geotechnical issues at the east end of the structure, the Chamberlain bridge has been identified for replacement within the study period.

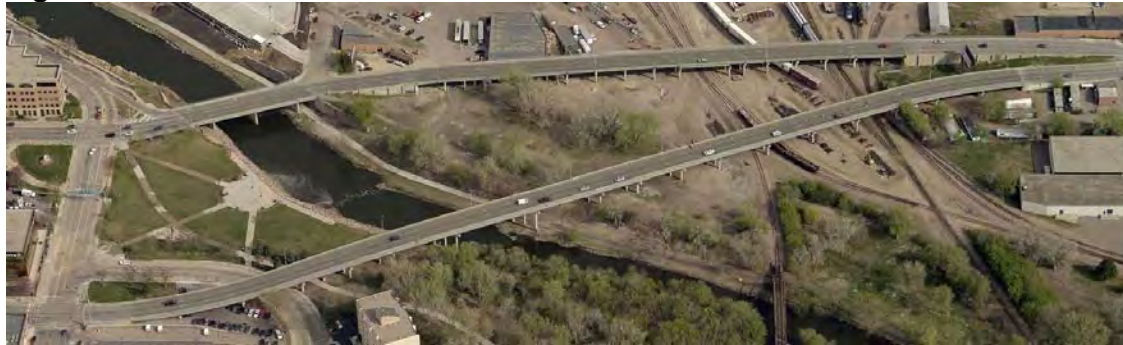
Figure 19.7 11th Street Viaduct

The bridge has the following traffic volume: ADT (2015) of 12,062. The superstructure is a redundant multi-girder system.

- Inspectability
 - *Superstructure*: Superstructure accessible by snoopers or lift
 - *Substructure*: Piers accessible from dry land
 - *Foundation*: Buried foundations, but effects due to potential defects will be visible
- Predictability
 - *Superstructure*: Multi-girder configuration, horizontal curve
 - *Substructure*: Three-column bents mostly on dry land
 - *Foundation*: Some individual spread footings, spread footings at piers adjacent to river
- Critical Factor
 - *Superstructure*: Multi-girder system with good redundancy
 - *Substructure*: Three-column bents with good redundancy; no railroad crash walls are present at the bents near the tracks. Crash walls are planned for the future, which would require an update of the uncertainty rating.
 - *Foundation*: Multiple footings founded on quartzite with good redundancy

- Historical Evidence
 - *Superstructure*: Minor fatigue cracking appears to be stable
 - *Substructure*: Minor surface cracks appear stable
 - *Foundation*: No notable deficiencies recorded
- Inconvenience to user
ADT = 12,062 Detour Length = 1 mile
- Frequency of Inspection
 - *Superstructure*: 24 months
 - *Substructure*: 24 months
 - *Foundation*: Buried – not visible

Table 19.11 summarizes the uncertainty index for this bridge. The superstructure and foundation have medium uncertainty and will likely require increased maintenance to preserve their lifespans. The superstructure has moderately low uncertainty and will require routine maintenance. SDDOT has an agreement to eventually relinquish full ownership responsibility, including maintenance of the 11th Street Bridge, to the City of Sioux Falls. Once a major rehabilitation project or replacement occurs, the City will assume responsibility for maintenance. Based on these conditions, the 11th Street Bridge has been identified for replacement in the financial uncertainty mitigation plan. However, the engineering uncertainty index indicates that replacement within the study period is not required.

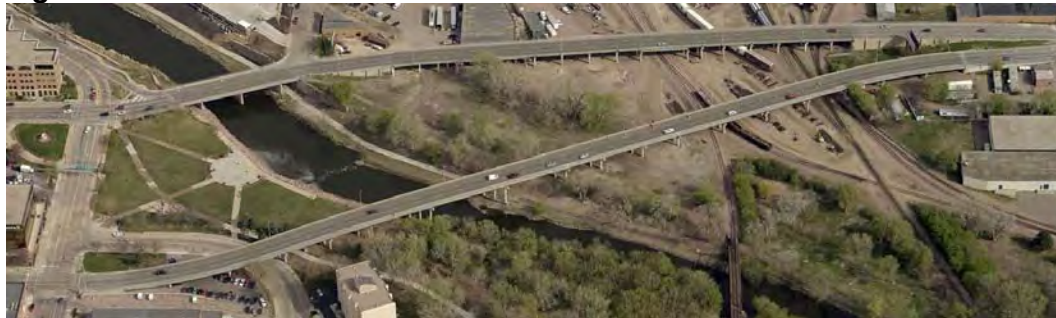
Figure 19.8 10th Street Viaduct

The bridge has the following traffic volume: ADT (2015) of 12,602. The superstructure is a redundant multi-girder system.

- Inspectability
 - *Superstructure:* Superstructure accessible by snoopers or lift; however, gunite on some girders makes detection of defects more difficult

- *Foundation:* Individual spread footings on dry land
- Critical Factor
 - *Superstructure:* Multi-girder system with good redundancy
 - *Substructure:* Three-column bents with good redundancy; no railroad crash walls are present at the bents near the tracks. Crash walls are planned for the future, which would require an update of the uncertainty rating.

- *Foundation:* Multiple footings founded on rock with good redundancy
- Historical Evidence
 - *Superstructure:* Cracked welds at bearings, substantial section loss noted at girders

- *Substructure:* Minor cracks and spalling at piers, moderate cracks at abutments
 - *Foundation:* No notable deficiencies recorded

Table 9.12 summarizes the uncertainty index for this bridge. This evaluation indicates that the superstructure, substructure, and foundation have medium uncertainty and will likely require increased maintenance to preserve their lifespans. SDDOT has an agreement to eventually relinquish full ownership responsibility including maintenance of the 10th Street Bridge to the City of Sioux Falls. Once a major rehabilitation project or replacement occurs, the City will assume responsibility for maintenance. Based on these conditions, the 10th Street Bridge has been identified for replacement in the financial uncertainty mitigation plan. However, the engineering uncertainty index indicates that replacement within the study period is not required.

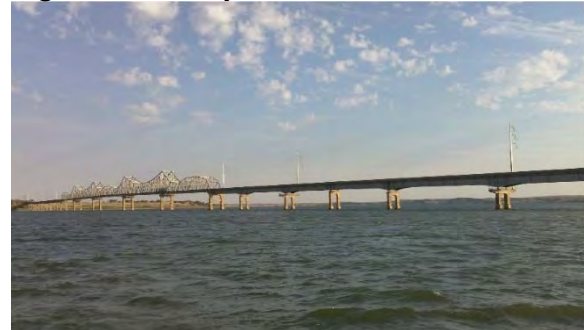
Figure 19.9 Upstream Elevation

- *Foundation:* Underwater
- Predictability
 - *Superstructure:* Two-girder system with floor beams and stringers, plus cantilevered through-truss spans with pin and hanger end support details on the drop-in truss simple spans

- *Superstructure:* Two-girder system, cantilevered truss; failure of one truss component or approach span girder could lead to catastrophic failure of the bridge

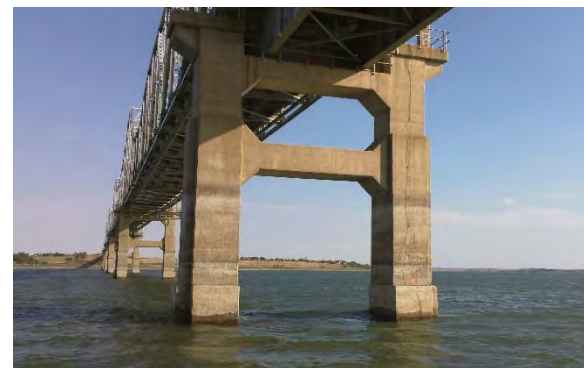
Figure 19.10 Piers

- *Substructure:* Two-column bents throughout with bottom diaphragm on tall piers
 - *Foundation:* Single combined footings with H-piles
- Critical Factor

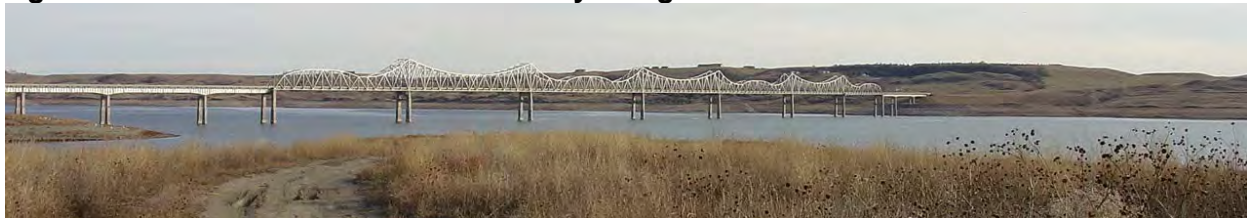
Figure 19.15 Elevation of Forrest City Bridge

The bridge has the following traffic volume: ADT (2015) of 541. The superstructure is a non-redundant through-truss with non-redundant approach spans consisting of a two-girder system.

- Inspectability
 - *Superstructure:* Truss is difficult to fully inspect
 - *Substructure:* Piers are in water but partially visible from snooper or boat (half of column height is below water level)

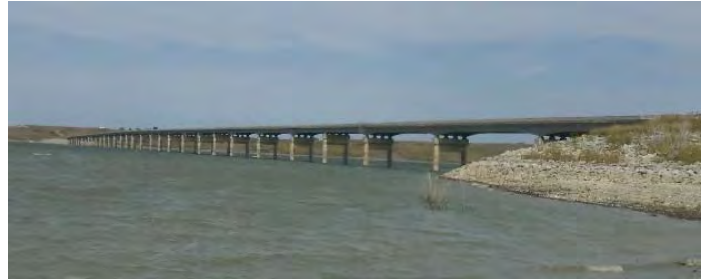
Figure 19.16 Elevation of Singing Bridge

- *Foundation*: Minor (<5') scour at some piers; Moderate honeycombing and spalling at some footings appear generally stable
- Inconvenience to user
ADT = 826 Detour Length = 27 miles

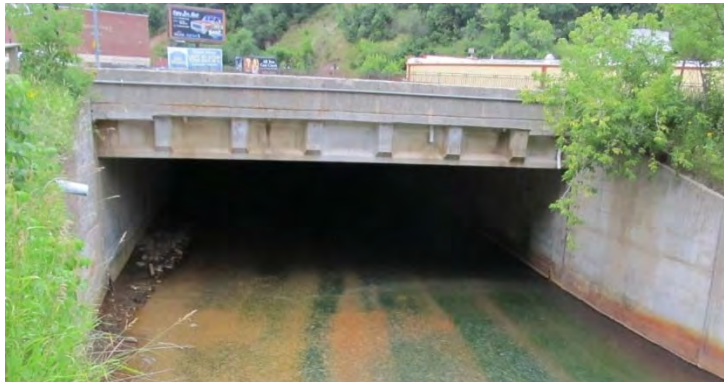
Figure 19.18 Deadwood Structure Outlet

The bridge has the following traffic volume: ADT (2015) of 11,269. The superstructure is a redundant floor beam and stringer system.

- Inspectability
 - *Superstructure*: Top of superstructure not visible due to overlay, access below difficult due to length of buried structure
 - *Substructure*: Upper portions difficult to access

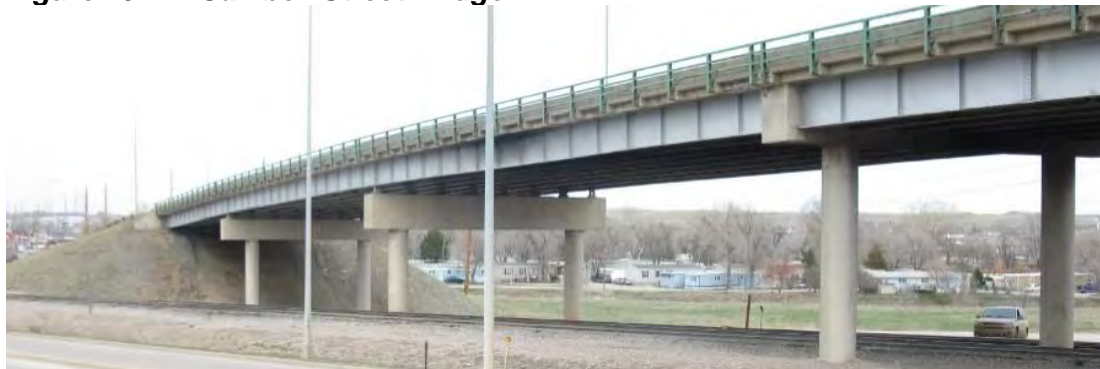
Figure 19.21 Cambell Street Bridge

The bridge has the following traffic volume: ADT (2015) of 20,559. The superstructure is a redundant multi-girder system.

- Inspectability
 - *Superstructure*: Superstructure accessible by snoopers or lift
 - *Substructure*: Piers are accessible from dry land
 - *Foundation*: Buried foundations, but effects due to potential defects will be visible
